# Hilton Hotel, Sydney

## Case Study

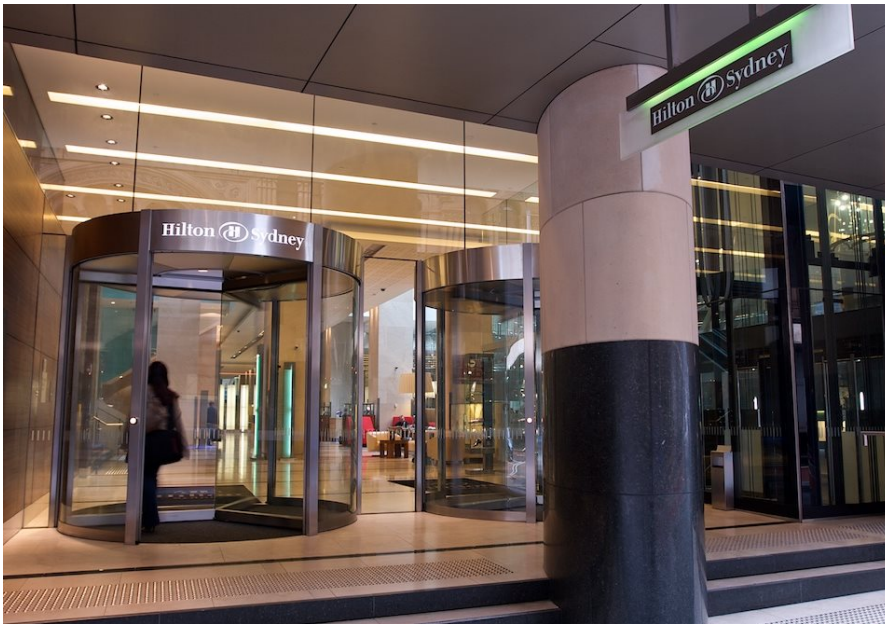
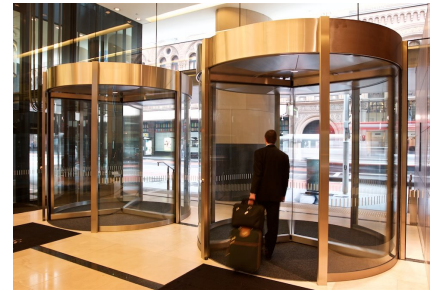
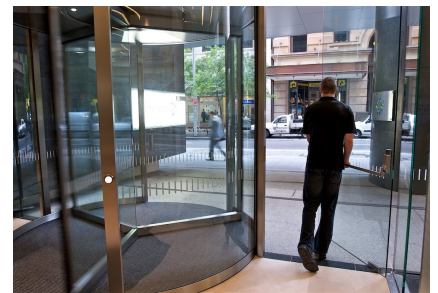
With the existing main entry sliding doors on Geogee Street, as well as the rear entry off Pitt Street, causing persistent wind problems for hotel staff and guests, the decision was made to replace these sliding doors with revolving doors to achieve airlocked entries to the hotel.

In an extensive site operation, the existing sliding doors were removed, along with the highlight glazing which was being supported off the steel transom.

Two Fullview revolving doors were then installed to the George Street entry, along with one Fullview door and motorised swing door to the Pitt Street entry. All doors were clad in lined stainless steel with custom illuminated canopy signage.

To maintain the existing requirement for smoke ventilation in an emergency, each revolving door was fitted with an automatic windback door wing to open on a re-trip signal.

For greater security after hours, the doors were fitted with motorised 'clamshell' night doors, which are in fact the sidewalls of the doors themselves automatically closing and electrically locking once the door, and associated lighting is turned off.
